# **LEAD-BASED PAINT INSPECTION REPORT**

QUEENS MOTEL  
16959 STODDARD WELLS ROAD  
VICTORVILLE, CA

PROJECT NO. 3008709

DECEMBER 19, 2016

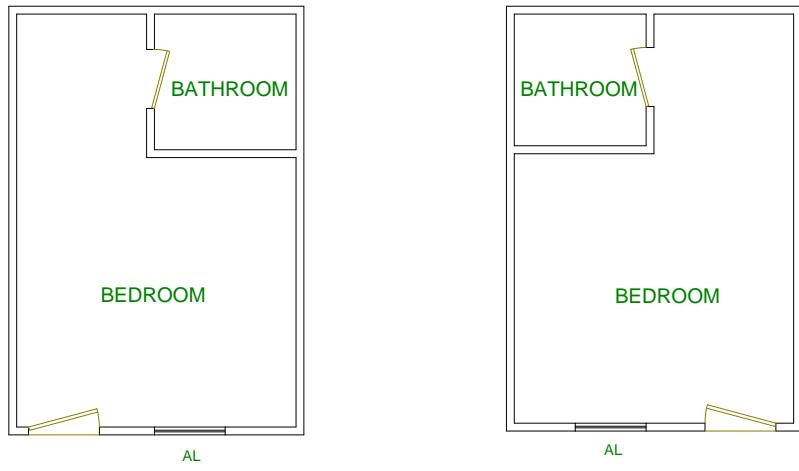
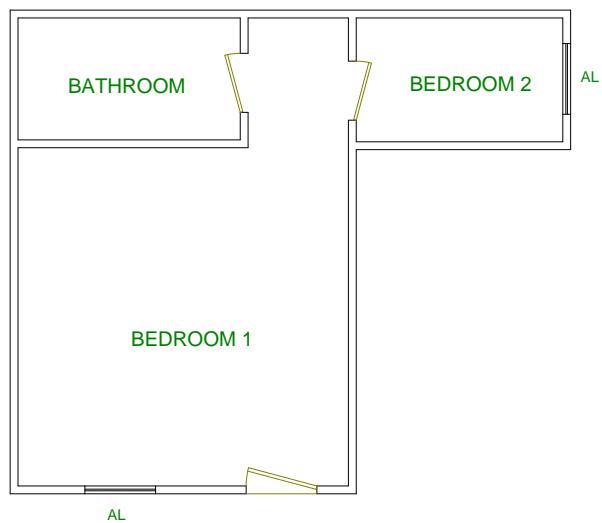
*MAP(S)*

Queens Motel  
16959 Stoddard Wells Road  
Victorville, CA  
Project# 3008709

This inspection was planned, developed, and implemented based on Integrated Property Analysis, Inc.'s previous experience in performing lead-based paint inspections. This inspection was patterned after Chapter 7 of the *HUD Guidelines for the Evaluation and Control of Lead-Based Paint Hazards in Housing (2012 Revision)*. Integrated Property Analysis, Inc. utilized state-of-the-art-practices and techniques in accordance with regulatory standards while performing this inspection. Integrated Property Analysis, Inc.'s evaluation of the relative risk of exposure to lead identified during this inspection is based on conditions observed at the time of the inspection. Integrated Property Analysis, Inc. cannot be responsible for changing conditions that may alter the relative exposure risk or for future changes in accepted methodology. Enclosed are the diagram(s), actual test results, and all relevant certifications and licenses.
